Airborne multispectral scanning of subsidence caused by Permian gypsum dissolution at Ripon, North Yorkshire

Abstract

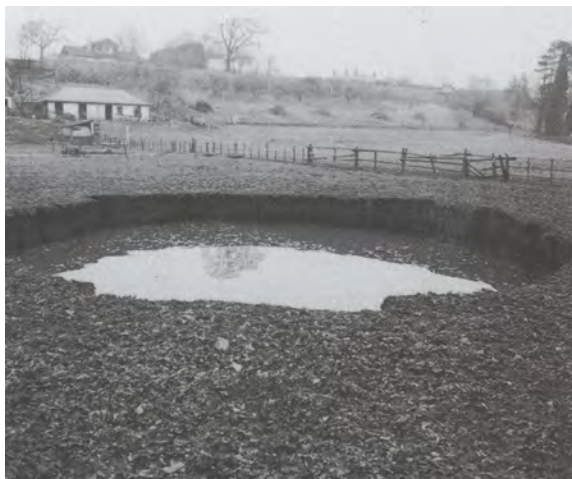
FIG. 2. Water-filled subsidence hollow which formed on 1st February 1982 at Sharow [SE 3238 7182]. The hollow was 12 m in diameter and up to 9.7 m deep.

The phreatic flow of groundwater through the rock dissolves the gypsum mainly along the joints. This has produced a cave system in the gypsum with caverns at the intersections of the joints (Cooper 1986). As the dissolution of the gypsum continues at a rapid rate the caverns enlarge, amalgamate, become unstable and ultimately collapse. The dates and locations of historically recorded subsidences are shown in Fig. 10. When failure of the cavity roof occurs a breccia pipe may work its way up to the surface causing subsidence features to develop (Cooper 1988). These range from slight sagging, to small crown holes with large voids beneath, through to complete catastrophic collapse (Fig. 2). The larger subsidences may be up to

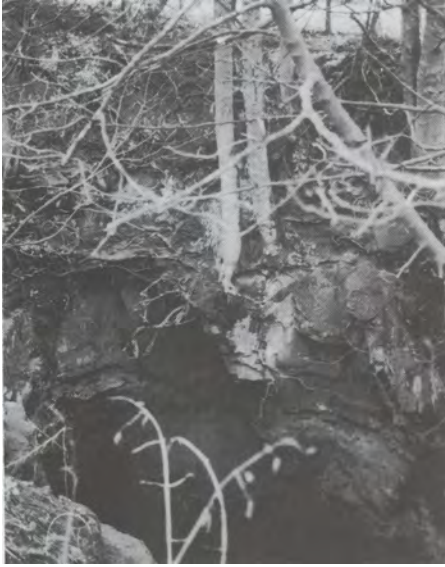
FIG. 3. Subsidence hollow formed in July 1834 near Ripon Railway Station [SE 3186 7260]. The cylindrical hollow is 14 m in diameter and 15 m deep with red Sherwood Sandstone exposed in its sides.

The physical nature of the major subsidence hollows depends on the surface geology. Cylindrical shafts generally form where rock is present at the surface (Fig. 3), but failure of the sides in superficial deposits causes conical depressions to develop (Fig. 4). These subsidence features occur in a linear or

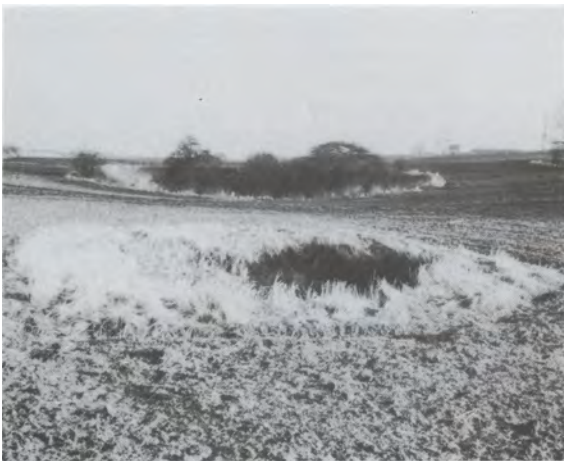
FIG. 4. Subsidence hollows at Corkscrew Pits [SE 320 732] Hutton Conyers. These pits are shown on Figs 6B, 7B & 8 near the caravan site.

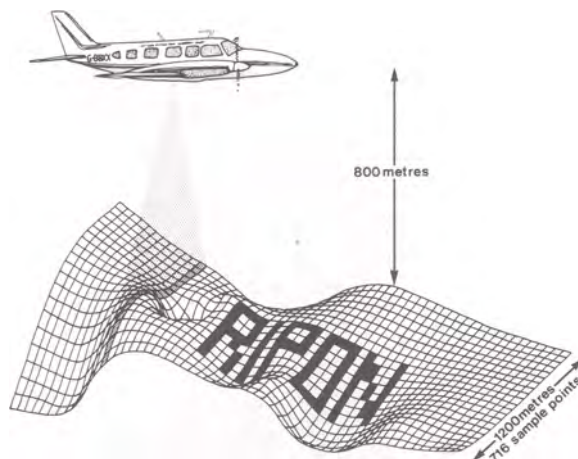
FIG. 5. Data collection using an airborne multispectral scanner. Aircraft height about 800 m, swath width about 1.2 km, sample point size 1.5–2.0 m, 11 channels of data (Table 1). The scanner sweeps in lines 716 sample points wide across the ground as the aircraft moves forward.

The Daedulus AADS 1268 ATM scanner collects an image of the ground in electronic form recording eleven channels of data on high-density digital tape. These channels cover the visible, near infra-red and thermal part of the electromagnetic spectrum (Table 1) (White 1986; Williams 1984). The scan angle (+43°) and instantaneous field of view (2.5 mrad) are constant so that swath-width and resolution of the instrument is largely dependent on the height at which it is flown. The Ripon area was surveyed from a height of around 800 m giving a resolution of 1.5–2.0 m on the ground (Fig. 5); this was the

maximum resolution for the 1986 scanner campaign. Thus for each sample point of approximately 1.5–2 metre square, eleven channels of data were collected, each channel recording the average intensity of reflected or emitted radiation over a narrow spectral band for the sample point. Each swath was 716 pixels or sample points wide giving a ground width of about 1.2 km. The high resolution was essential to pick out the smaller subsidence features which the initial field survey showed to be upwards of 1.5 m in diameter. The collection of scanner information at this high resolution produces a very large data-set. Consequently only a small area of about 6 km² was collected by the Ripon survey. After collection the electronic data was processed into a standard digital form on computer compatible tape by Hunting Surveys Ltd. These digital recording were then re-constituted by computer as television pictures with each pixel representing an approximate two metre square sample point on the ground.

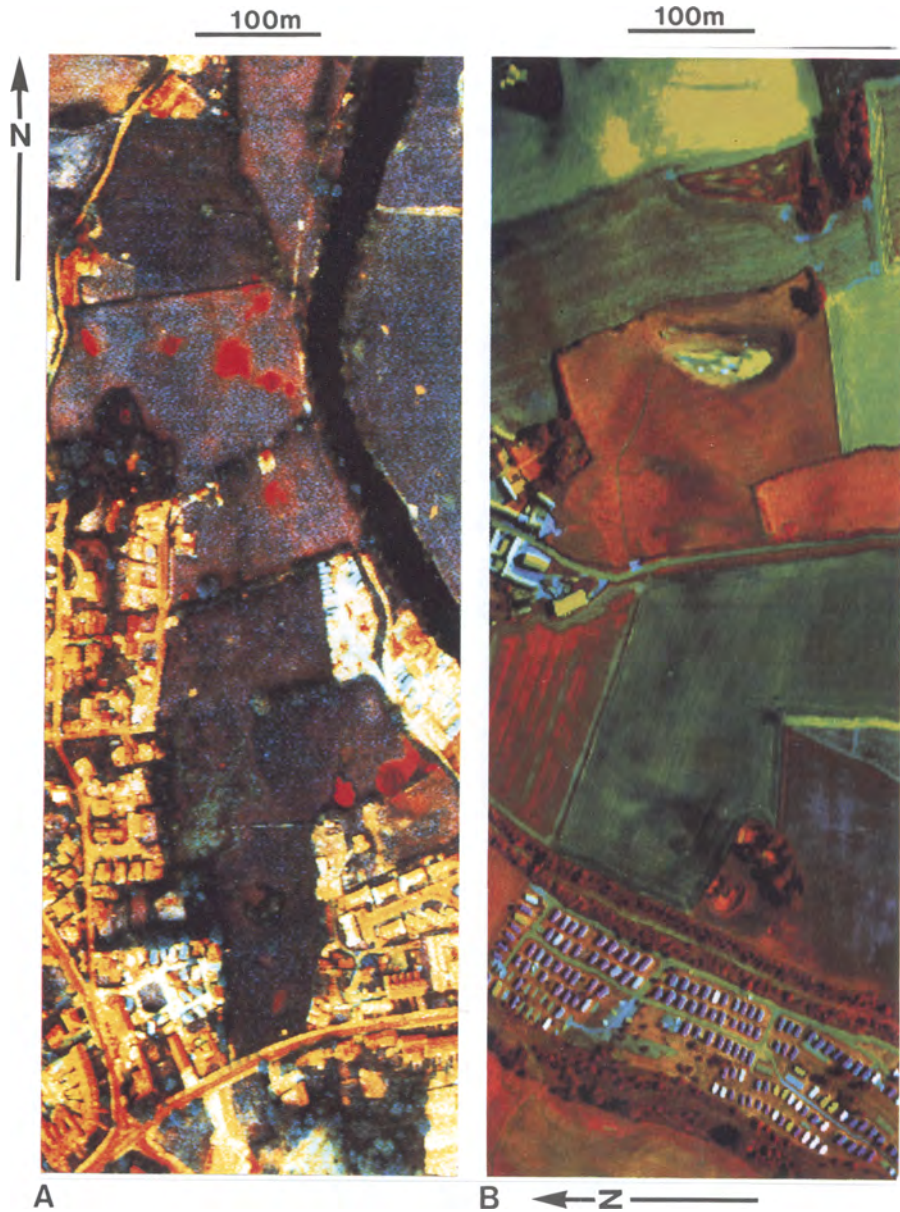
FIG. 6. (A) Multispectral scanner image of subsidence hollows in the area south of Low Common Farm and north of Ripon Clock Tower (see Fig. 10 for location and Fig. 7A for explanation). This image was gathered under complete cloud cover. It uses bands 11, 9, 10 and is scaled giving a false colour image that shows water filled hollows as red on a purple-green background. This band combination also shows vegetation changes in subdued subsidence areas. This image has slight oblique distortion (Fig. 10). (B) Multispectral scanner image of subsidence hollows near Hutton Conyers (see Fig. 10 for location and Fig. 7B for explanation). This image uses bands 7, 11, 5. It was gathered in full sunlight and has been scaled. The false colour image shows variations in soil and vegetation. Compare with Fig. 8 of the same area.

The false colour combination using the near infra-red, thermal and red wavebands (bands 7, 11, 5) showed considerable scope for identifying vegetation variations (Fig. 6B). With this band combination healthy vegetation shows red on the images (Fig. 6B and Fig. 7B, a) and cold areas of water show black; water-filled subsidence hollows being particularly clear. The spring-flown images were generally better than the autumn ones for crop detail, the winter barley showing some variation (Fig. 6B and Fig. 7B, b) but the autumn stubble none. In retrospect surveys during spring and summer may have provided more detail for areas heavily cropped with winter barley. The images of short and parched grassland taken in the autumn showed considerable variation and numerous details of the subsidence features.

Some of the runs of data collected in the spring had considerable cloud cover, resulting in fairly dull images in the visible and near infra-red wavebands. These images, however, provided more detail in the thermal and far infra-red wavebands. A combination of bands 11, 9, and 10 showed water filled subsidence hollows with a red colour on a general background of green or purple-green for vegetation (Fig. 6A and Fig. 7A, d). This waveband combination also detected water in deep subsidence hollows surrounded by trees and enveloped in shadow (Fig. 6A and Fig. 7A, e). Vegetation variations in subsidence areas also showed up well (Fig. 6A and Fig. 7A, f).

When compared with the known distribution of subsidence hollows (Cooper 1986) it was found the majority were detected by the MSS survey. In addition new definite or probable sites of subsidence were identified. These include linear belts of soil and vegetation anomalies along Skittergate Gutter [SE 320 714], near High Common Farm [SE 310 726] and east of Ure Bank [SE 326 725]. South of Low Common Farm [SE 313 721] the MSS survey also showed details of individual subsidence areas within a large subsidence hollow (Fig. 6A and Fig. 7A, f); this detail

air photographs (Fig. 6A and Fig. 7A, f). Generally the images obtained in full sunlight yielded the best results (Fig. 6B), although one image gathered under complete cloud cover showed considerable detail in the far infra-red and thermal parts of the spectrum (bands 11, 9, 10). This image was particularly useful for delineating water-filled subsidence hollows (Fig. 6A and Fig. 7A, d, e). In a few places there were discrepancies between the MSS, air photograph and field surveys; these were checked on the ground. The problems mainly arose with the coarser resolution of the MSS data; for example, this was inadequate to identify an area of coarse vegetation around a telegraph pole [SE 3204 7318].

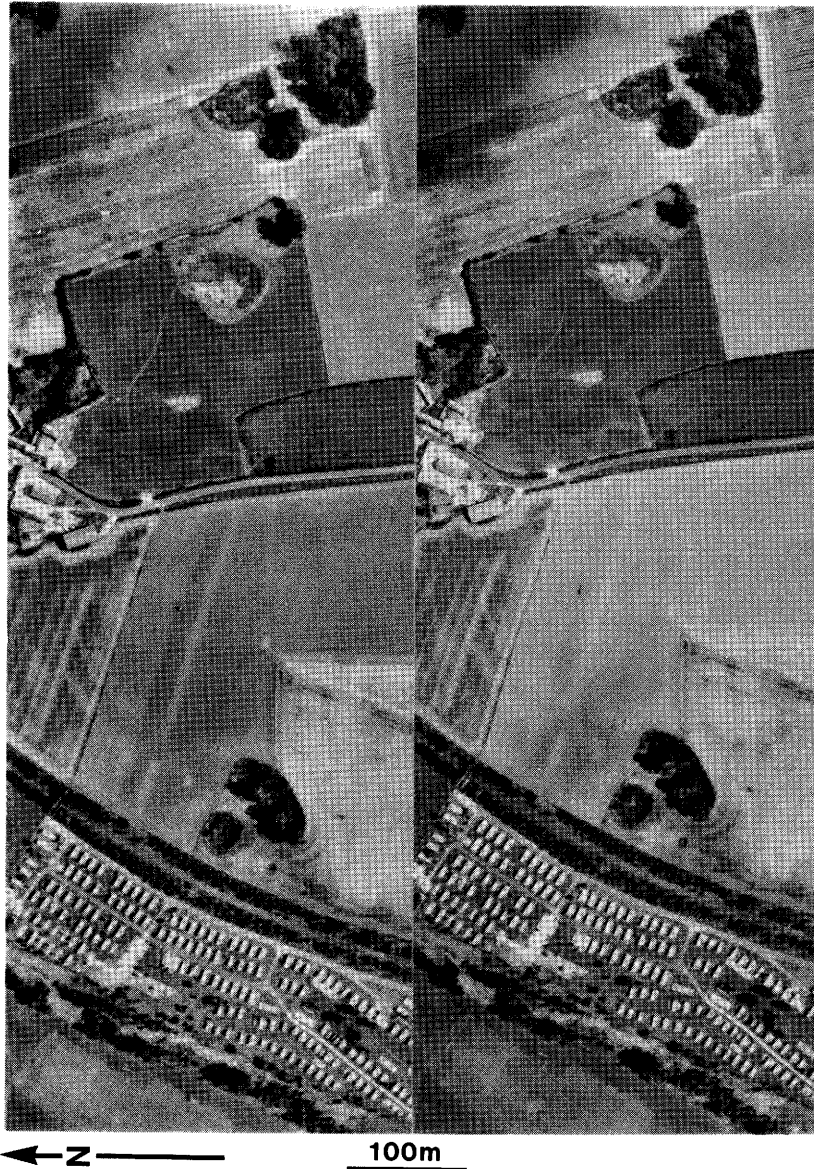
FIG. 8. Stereo pair of photographs of subsidence hollows near Hutton Conyers (see Fig. 10 for location). Note also the bluff and alluvial flat just below the caravan park at the bottom of the photographs. To view this use a pocket stereoscope or hold a 15 cm high piece of grey card vertically between the two photographs in line with your nose, stare at the photographs, but let your eyes relax. You should see three images with the central one in 3D.

The stereo air photography also identified much of the glacial and recent geology of the Ripon area. The most marked feature, the flood plain of the River Ure and its tributaries, was obvious because of its flatness and marginal features (bottom of Fig. 8; see Fig. 7B
