Subsidence hazards caused by the dissolution of Permian gypsum in England: geology, investigation and remediation

A. H. Cooper

Geological Society, London, Engineering Geology Special Publications 1998; v. 15; p. 265-275
doi:10.1144/GSL.ENG.1998.015.01.27

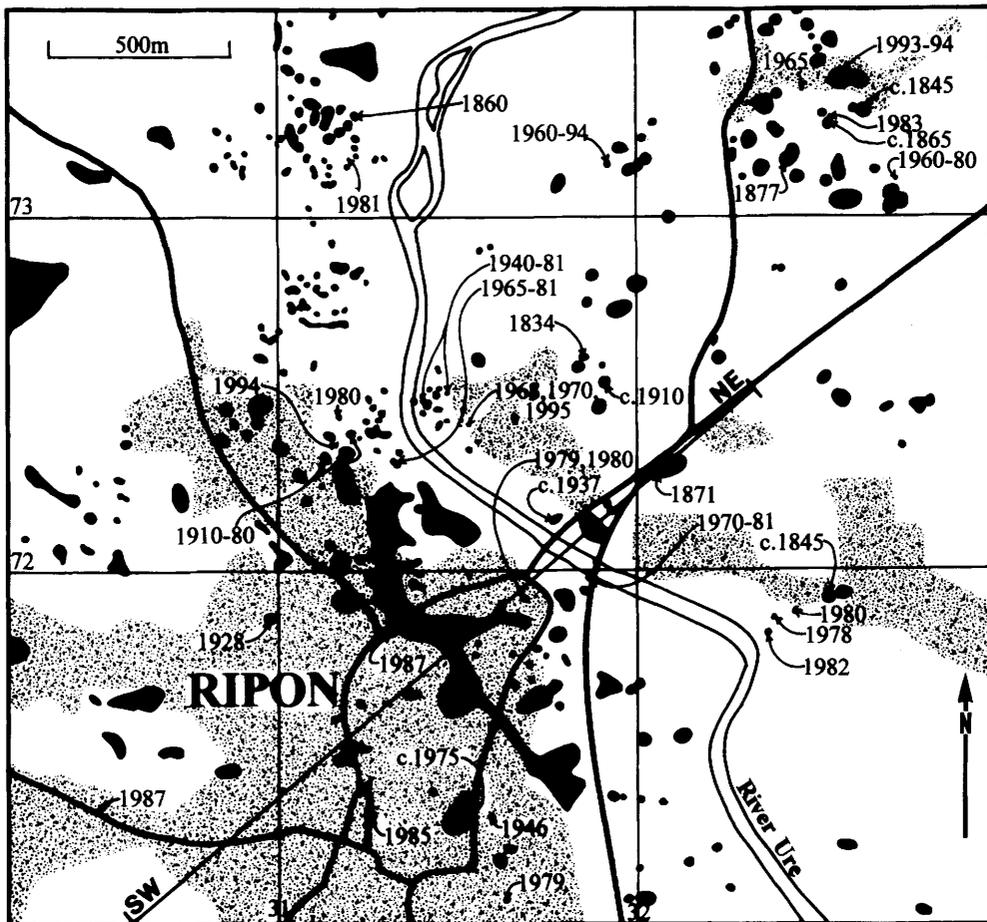
Fig. 1. The distribution and ages of subsidence hollows recorded in the vicinity of Ripon, North Yorkshire. The built-up area is shaded; subsidence hollows are shown in black. The approximate line of the section (SW–NE) illustrated in Fig. 2 is shown.

In England, Ripon suffers the worst subsidence caused by gypsum dissolution. Here at least 30 major collapses have occurred in the past 150 years and further collapses might be expected every two to three years (Cooper 1986, 1988, 1989, 1995). The subsidence hollows are commonly 10–30 m in diameter and reach 20 m in depth; east of the city they attain dimensions of up to 80 m diameter and 30 m deep. Numerous sags and small collapses on farmland go undetected, but careful analysis of historical levelling data suggests some areas of general ground lowering (Hogbin 1994). Many of the subsidence features at Ripon are arranged in a reticulate pattern (Fig. 1) related to the intersections of the joint systems in the rock (Cooper 1986).

The dates and locations recorded for the historically recent subsidence events suggest concentration of water flow in the cave systems along certain specific paths (Fig. 1). The close grouping of subsidence hollows suggests that once a collapse has occurred the cave partially chokes and the dissolution continues in the adjacent strata. This commonly produces linear belts of subsidence related to the joint pattern. It also means that localities adjacent to, or in line with, existing subsidence hollows are probably more at risk from future subsidence (Fig. 10).

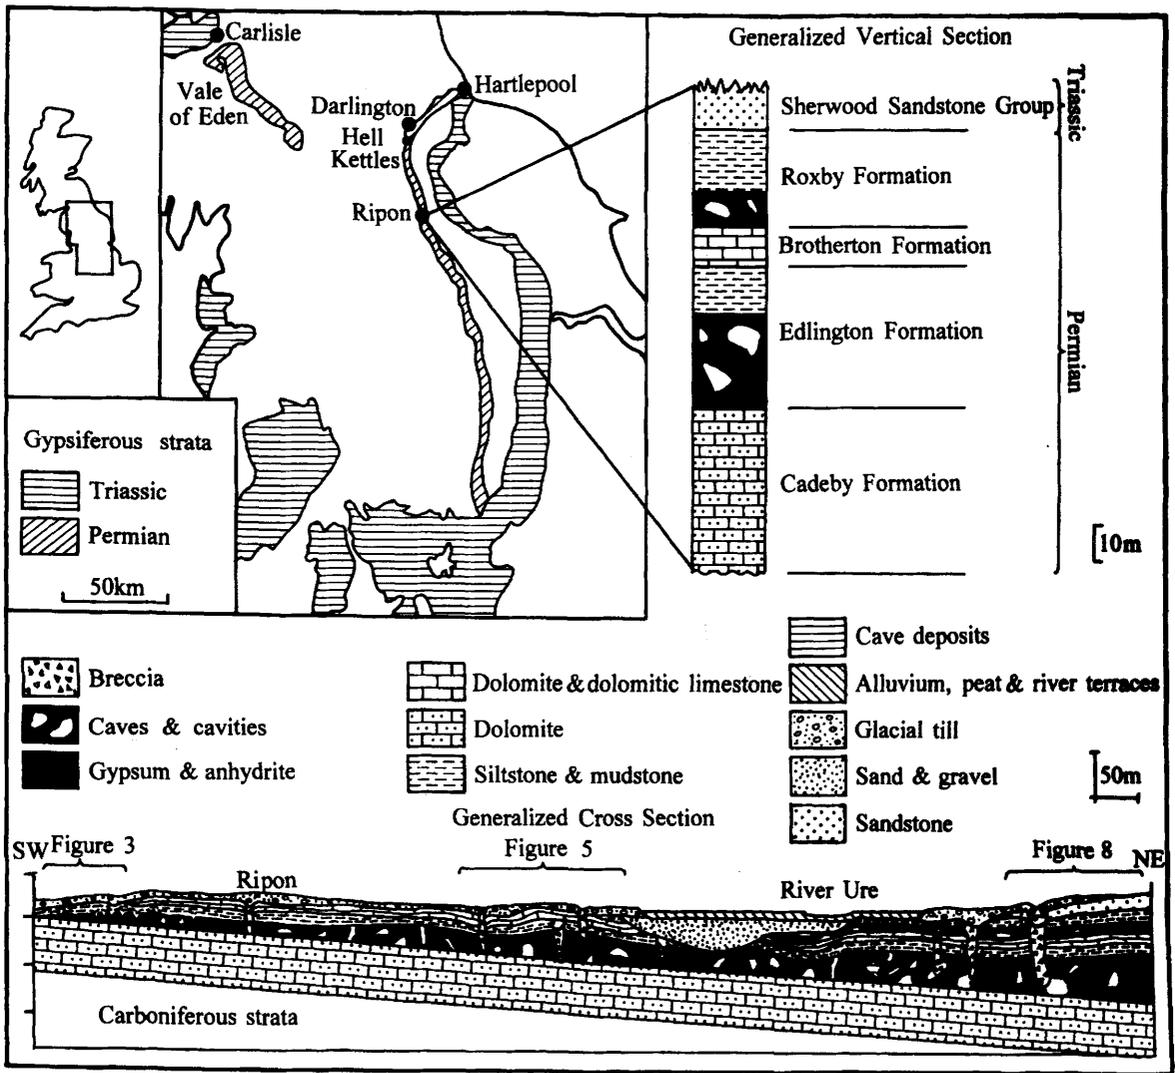
Fig. 2. Distribution of gypsiferous strata in northern England and the Permian sequence in Yorkshire (inset map). The sketch geological cross-section (approximately along line SW-NE in Fig. 1) illustrates the geology around Ripon. It shows caves in the gypsum sequence and their upwards propagation as breccia pipes. The legend is also that for Figs 3, 5 and 8, whose approximate positions are shown on the cross-section.

The strata of the subsidence belt (Fig. 2) are mainly of Permian age. They comprise a lower carbonate (Cadeby Formation, 60 m thick) overlain by the Edlington Formation which consists of up to 40 m of gypsum overlain

from gypsum to anhydrite (Cooper 1986). The gypsum belt extends from Hartlepool, through Darlington and Ripon to near Doncaster. It has a maximum width of about 3 km and extends to a depth of around 100 m. From west to east across the belt the gypsum units show a progression from complete dissolution of gypsum, through buried pinnacled gypsum karst, to gypsum with caves and subsidence features, then finally to anhydrite (Fig. 2).

The localized character of the subsidence features is dependent on the underlying geological sequence and the superficial deposits at the surface. In the west of Ripon, only one sequence of gypsum is dissolving; in the east two are dissolving (Figs 2, 3, 5 and 8). In some places competent sandstone or limestone strata are present at the surface, in others soft mudstone is present. The situation is further complicated by differences in the Quaternary superficial deposits, which vary from thick valley-fill deposits to a blanket covering of glacial till (Fig. 2). Because of these variables, and as an aid to site investigation and subsequent design work, the nature of the geology and subsidence features from west to east across the area are described below.

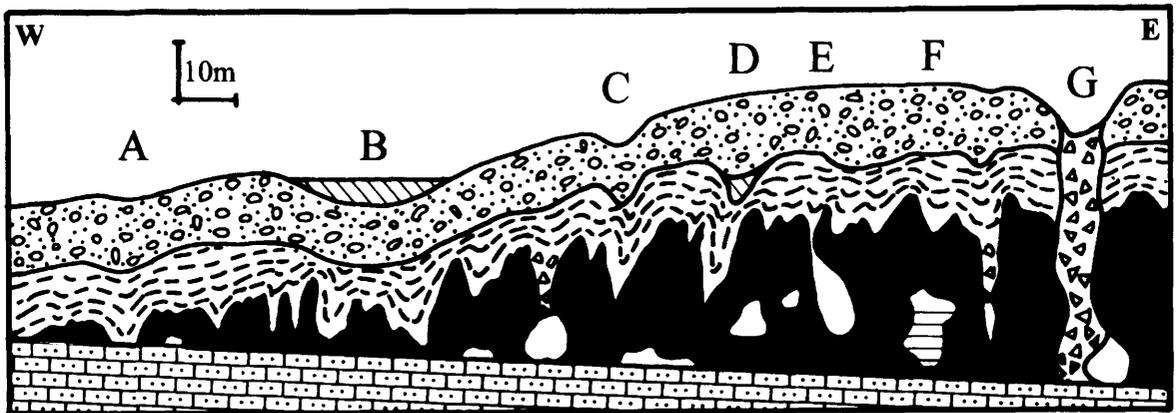
Fig. 3. Stylized cross-section through gypsum dissolution subsidence features in the west of the Ripon subsidence belt. See Fig. 2 for legend and the text for an explanation.

The main gypsum sequence in the Edlington Formation of Yorkshire rests immediately above the dolomite of the Cadeby Formation (Figs 2, 3, 5 and 8). At Ripon it comprises up to 40 m of massive gypsum overlain by about 10 m of red-brown calcareous and gypsiferous mudstone. In the west at its feather edge the gypsum dissolves to form a pinnacled gypsum karst into which the overlying mudstones and Quaternary deposits founder (A in Fig. 3). From borehole information, and by comparison with the pinnacled gypsum karst seen in the Vale of Eden (Ryder and Cooper 1993), it can be expected that within this belt the gypsum pinnacles may have vertical sides, or be undercut to become cavernous (E in Fig. 3). The pinnacles and dissolution furrows may be many metres in height. The lower part of the gypsum in contact with the underlying Cadeby Formation may also be considerably dissolved and cavernous (C in Fig. 3). Throughout much of the Ripon area the pinnacled gypsum karst is concealed beneath 10–20 m of collapsed mudstone and superficial deposits; these will not bridge large cavities and the size of the collapses will be limited by the bridging capabilities of the massive gypsum. In general, individual subsidence depressions less than 10 m across occur within this belt of rock (C and G in Fig. 3), but in some areas they are amalgamated into larger subsidence areas (B in Fig. 3). Some of the subsidence hollows will be the result of sagging and flow of the overlying deposits (C in Fig. 3), while others will be underlain by breccia pipes, possibly penetrating to the Cadeby Formation (G in Fig. 3). Caves may be expected anywhere within the gypsum,

and caves partially filled in with laminated clays (F in Fig. 3; Fig. 4), deposited from material held in suspension by cave waters, and collapse breccias have been recorded. Within this area and in many of the areas to the east, fossil subsidence features predating the Quaternary glaciation may also be present. Thus subsidence hollows completely filled with glacial till, or laminated clay glacial deposits beneath the till, may occur (D in Fig. 3).

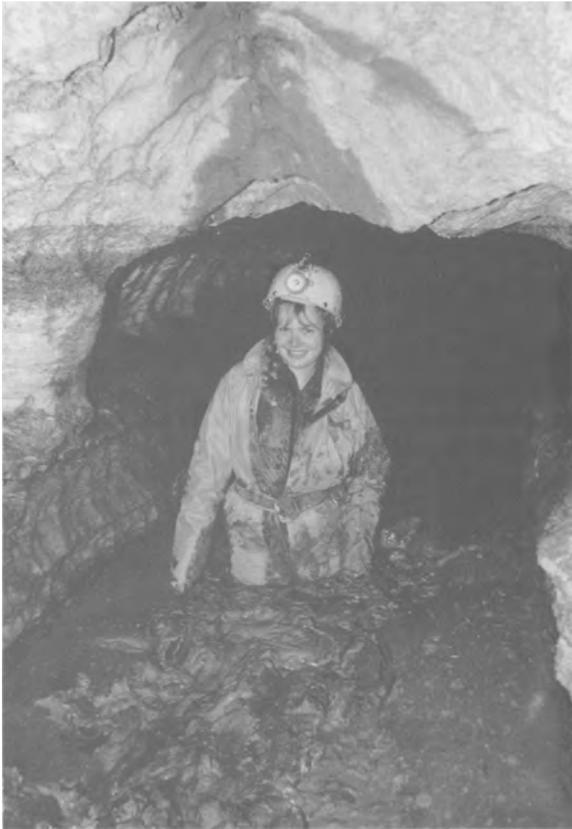
Fig. 4. Phreatic cave in the Permian, B-Bed gypsum at Houtsay Quarry [NY 624 276], Cumbria. The phreatic tube shows some preferential dissolution along some of the gypsum beds; the surface of the cave is also scalloped by dissolution. Some of the banding near the roof of the cave is water staining. The floor of the conduit is covered by thick glutinous mud to a depth of about 0.5 m (Ryder & Cooper 1993).

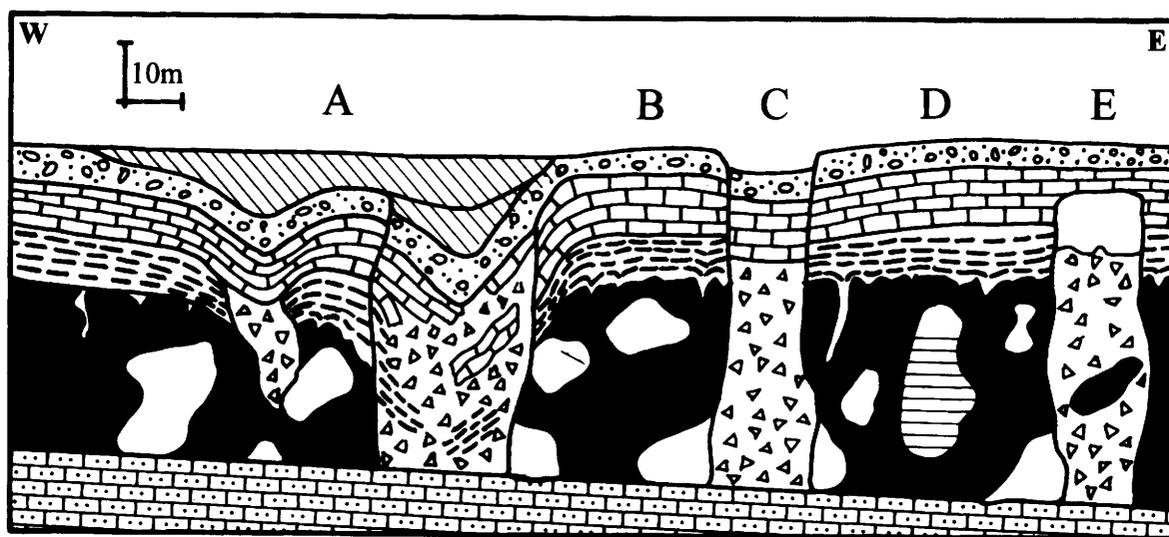
Fig. 5. Stylized cross-section through gypsum dissolution subsidence features in the centre of the Ripon subsidence belt. See Fig. 2 for legend and the text for an explanation.

Roxby Formation. The Brotherton Formation can bridge considerable cavities that emanate upwards from the underlying gypsum (E in Fig. 5). However, when it fails it can do so catastrophically, producing hollows up to 20 m across such as those at Magdalens Road (in 1979 and 1980), Ripon [SE 3170 7192], (Fig. 6), and Nunwick [SE 3184 7473] (Cooper 1986; C in Fig. 5). Since up to 40 m of gypsum could be dissolved from beneath it (B in Fig. 5), the whole of the Brotherton Formation outcrop has a potential for subsidence.

The Brotherton Formation limestones can bridge fairly large cavities and some of the gypsum caves below it have not collapsed. Instead they have become partially choked with cave deposits including laminated clay with subordinate peat and gravel washed into the cave system (D in Fig. 5). Thus it is possible to have a complex Quaternary sequence, at depth, underground beneath undisturbed surface geology. Breccia pipes penetrate the Brotherton Formation and include unconsolidated foundered material (Patterson *et al.* 1995), either Quaternary deposits or solid strata. In these pipes foundered areas of brecciated red-brown mudstone (derived from the Roxby Formation) or red sandstone (derived from the Sherwood Sandstone Group) commonly occur. Some of these collapse structures must be ancient because the stratigraphically younger formations, preserved in the pipes, have now been removed by erosion from the local area. Similar features penetrate the Brotherton Formation near Leeds at Sherburn in Elmet (Smith 1972). On the floodplain of the River Ure, subsidence hollows filled with unconsolidated organic-rich sand and silt occur. Some of these are further complicated by the presence of tufa-cemented deposits precipitated from artesian groundwater rich in dissolved carbonate.

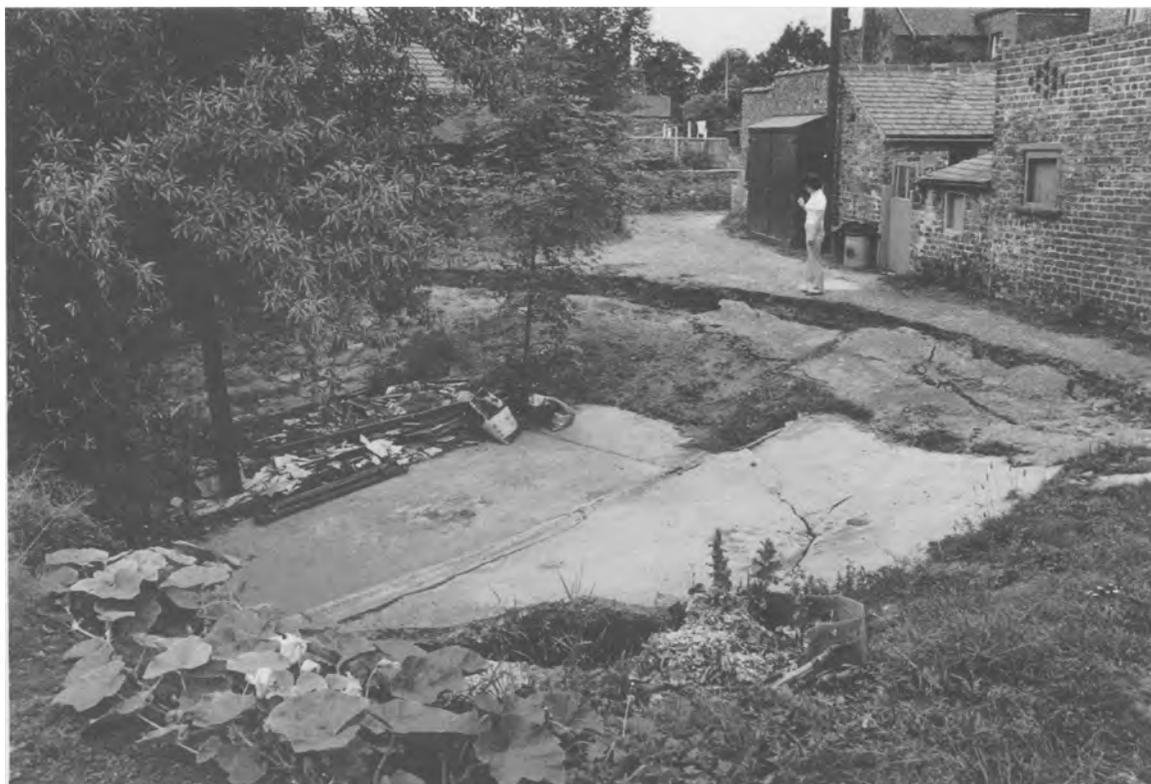
Fig. 6. Subsidence hollow that formed on 28 July 1979 behind houses on Magdalens Road, Ripon [SE 3170 7192]. This hole was filled in and subsided a similar amount in 1980. (Photo: Acrill Newspapers)

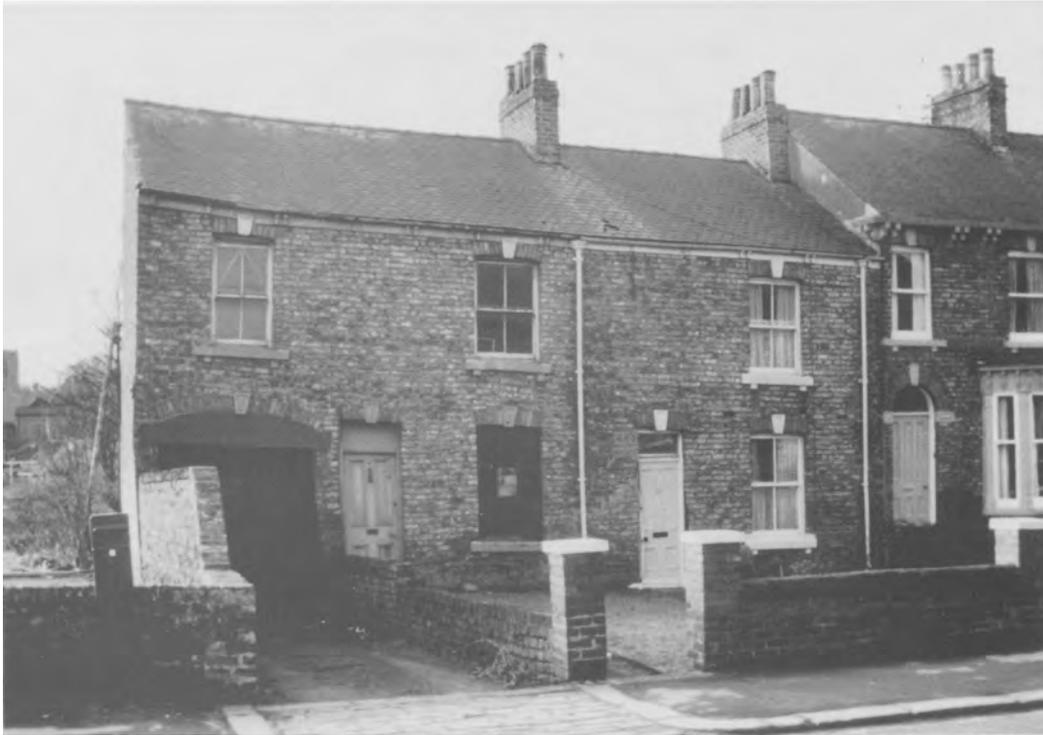
Fig. 7. Subsidence-damaged houses on Princess Road, Ripon [SE 3156 7266] showing a sagging mode of failure. These properties have suffered differential subsidence caused by settlement of peat within a large amalgamated subsidence hollow; active gypsum dissolution may also have contributed to the problem. This property has recently been demolished and has been rebuilt in a similar style on a piled foundation.

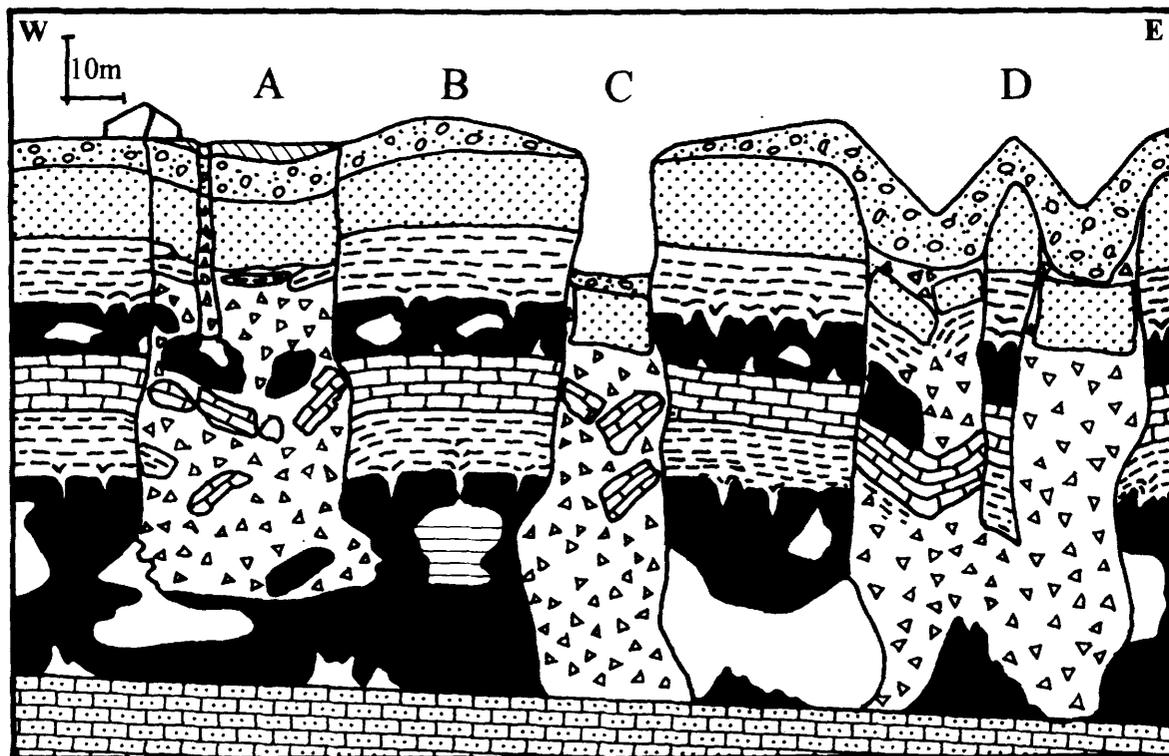
Fig. 8. Stylized cross-section through gypsum dissolution subsidence features in the east of the Ripon subsidence belt. See Fig. 2 for legend and the text for an explanation.

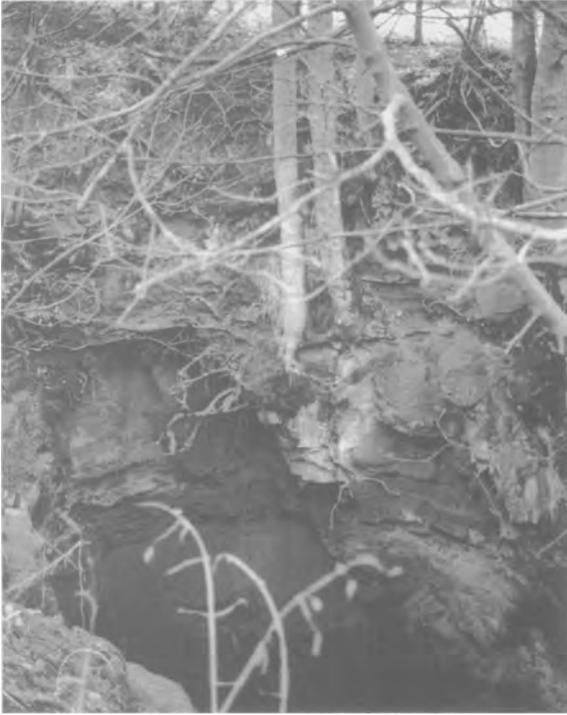
Fig. 9. Subsidence hollow formed in July 1834 near Ripon Railway Station [SE 3186 7260]. The cylindrical hollow is 14 m in diameter and 15 m deep with red Sherwood Sandstone exposed in its sides.

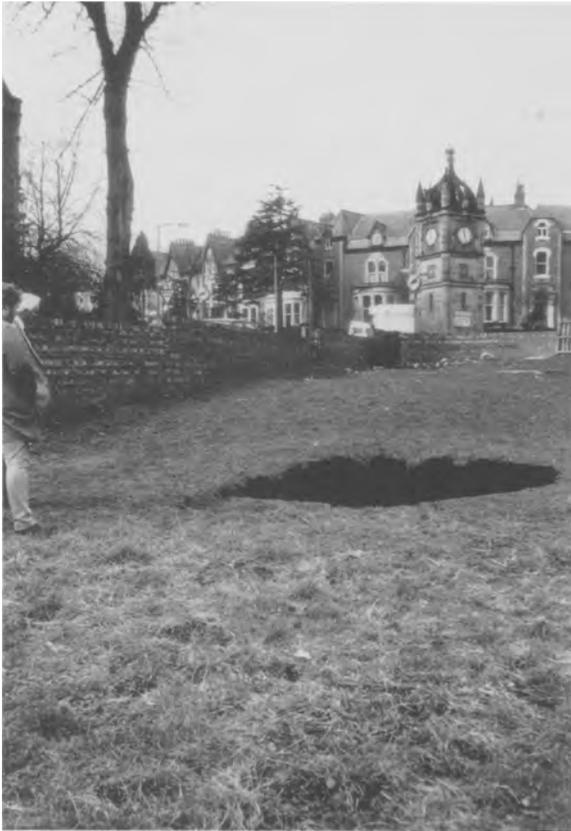
Fig. 10. Subsidence hollow that appeared in March 1987 near the Clock Tower [SE 3132 7281] in Ripon. This subsidence feature (5 m long, 3.2 m wide and 2.2 m deep) is in an area of glacial till adjacent to a large area of amalgamated peat-filled subsidence hollows (extending along Princess Road; see Fig. 7).
