Gypsum dissolution geohazards at Ripon, North Yorkshire, UK

ANTHONY H.COOPER¹

Abstract: This guide is for a one-day field excursion to examine gypsum dissolution geohazards at Ripon in North Yorkshire. Gypsum is a highly soluble rock and under suitable groundwater flow conditions it can dissolve forming caves and karstic features including collapse and suffusion dolines. These have the capability of causing subsidence damage of the type that affects much of the Ripon area. The guide details the processes involved, the localities visited and some of the remedial measures undertaken.

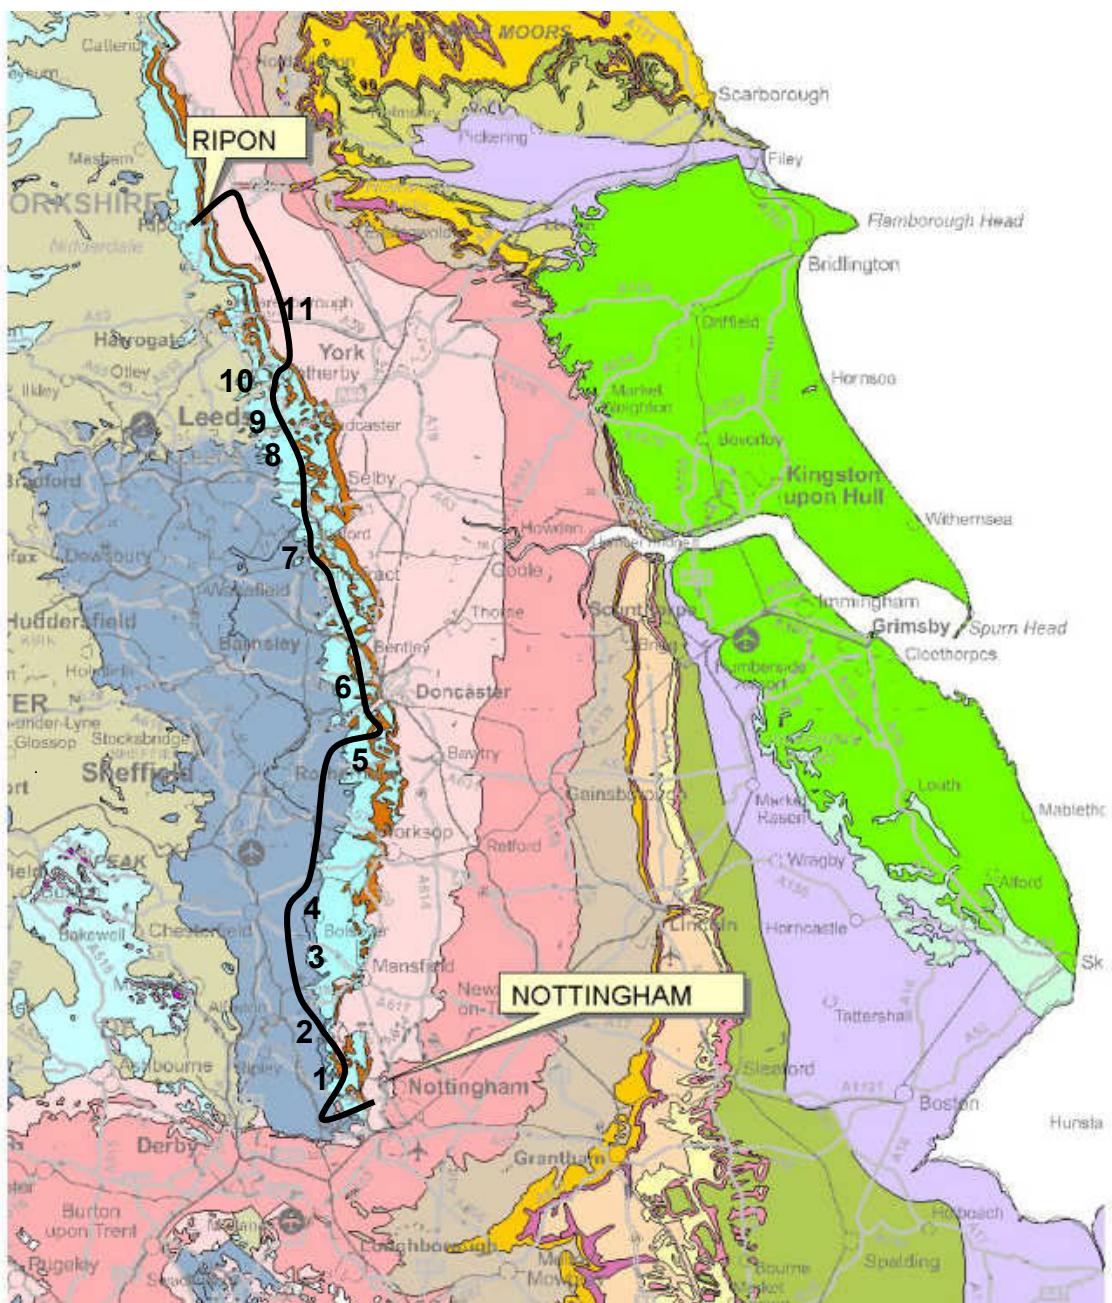
Figure 1. Extract from the 1:625,000 scale geological map for UK south (not to scale) showing the geology for the route from Nottingham to Ripon.

On the trip north from Nottingham the geology we see will be dependent on traffic conditions and the route the bus takes. The generalised geological sequence that we cross on the journey and see at Ripon is shown below in Table 1, and the most likely route and underlying geology in Figure 1.

we will head north across thin poorly exposed Permian strata belonging to the Zechstein Group (**1 on map**) and comprising thin dolomitic limestone of the Cadeby Formation which locally has a dolomitic mudstone sequence at its base (this sequence was formerly called the Lower Magnesian Limestone and Lower Marl). After about 15km we pass onto the Westphalian, Pennine Coal Measures Group (**2**) and drive for about 45km with the Permian escarpment just to the east of the motorway.

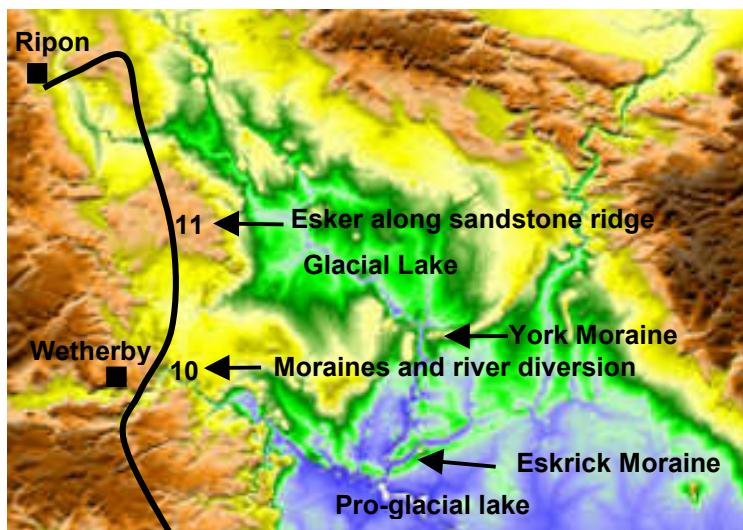
Figure 2. Digital Terrain Model (DTM) of the Vale of York. At locality 10 it shows the two moraines that come together at Wetherby and the diversion of the drainage from the west around the margin of the Devensian ice/moraine into the pro-glacial lake to the south. At locality 11 there is an esker running along the top of a ridge of Sherwood Sandstone. Digital Terrain data from Intermap Technologies, © BGS (NERC).

At Wetherby the landscape changes sharply as we cross the Devensian ice limit and pass through a cutting in the terminal moraines which here comprise the Eskrick and York moraines joined together (**10**). At this point the River Wharfe enters a shallow and narrow gorge, which is its diversionary route around what was the edge of the Devensian ice. At Wetherby the glacial till is up to around 40m thick, but north of here most of the land is blanketed by about 20m of glacial till and glacial lake deposits. About 8km north of here on the A1M we pass the A59 York junction and to the east (right) of the road there is an elongate esker deposit of sand and gravel running through Allerton Mauleverer; the ornate observatory folly is located on this ridge (**11**). About sixteen kilometres north of here we turn off for Ripon. The first stop is just to the north of Ripon on private land belonging to the Norton Conyers estate.

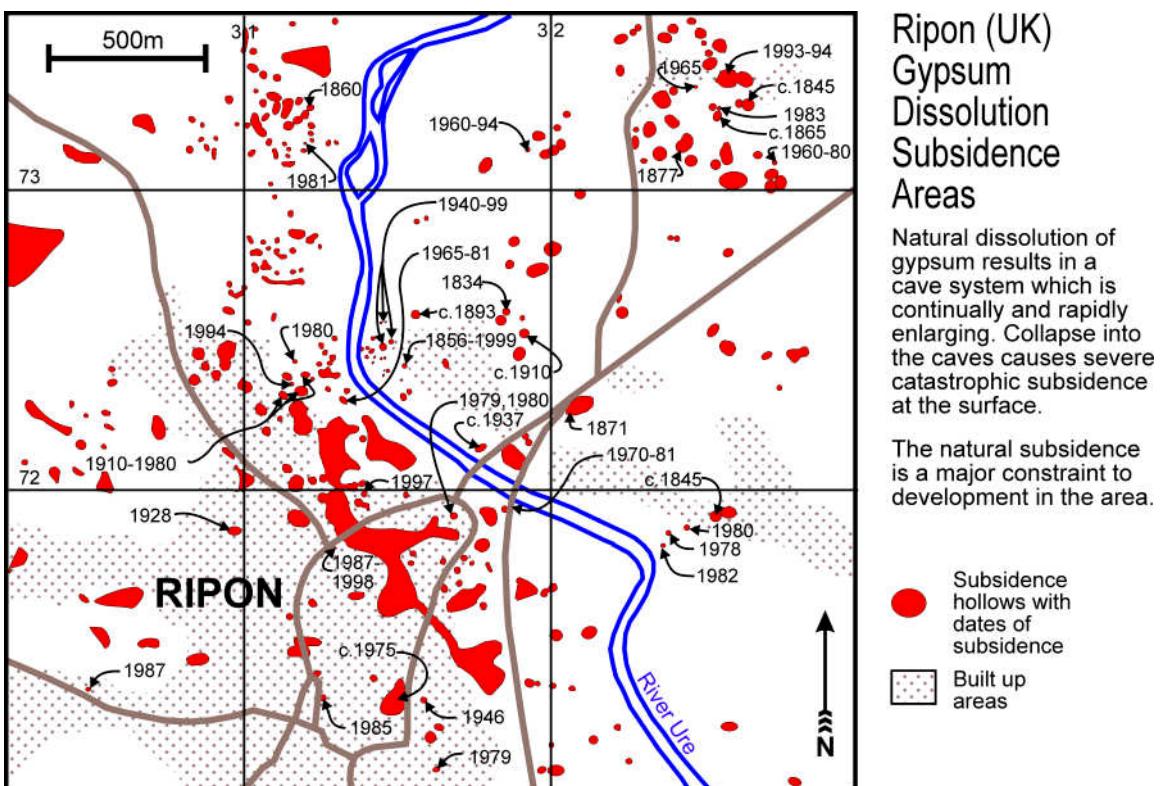
Figure 4. The distribution of subsidence hollows in the Ripon area with the dates of collapse where they are known.

The zone C area (which is most of Figure 4 except the very south-west corner) is subject to significant formal constraints and controls on development, which local planning has to take into account. In this zone, a ground stability report prepared by a competent professional person is normally required before planning applications for new buildings, or change of use of buildings, are determined. In most cases this report has to be based on a geotechnical desk study and a site appraisal, followed by a programme of ground investigation designed to provide information needed for detailed foundation design (unless this information, such as boreholes, exists from a previous study). Where planning consent is given it may be conditional on the implementation of approved foundation or other mitigation measures, designed to minimise the impact of any future subsidence activity. One key to the implementation of this approach is the use of a proforma checklist to be completed and signed by a competent professional person. For the UK a competent person is defined in the report as Geotechnical Specialist who is "A Chartered Engineer or Chartered Geologist, with a postgraduate qualification in geotechnical engineering or engineering geology, equivalent at least to an MSc, and with three years of post-Charter practice in geotechnics; or a Chartered Engineer or Chartered Geologist with five years of post-Charter practice in geotechnics". In addition to these qualifications it is also desirable that the practitioner has experience of the problems though this is not formally stated. This procedure has been adopted by Harrogate Borough Council, but is likely to be subject to minor changes with experience of its use. In general it is working well and removes the responsibility from the planners to the developers, but some sites where stability might be questioned have been developed.

Locality 10. Magdalen's Road subsidence hollow [SE 3179 7181]. This large peat-filled subsidence hollow lies at the side of the deep buried valley that follows the present river valley. (Figures 3 and 4).

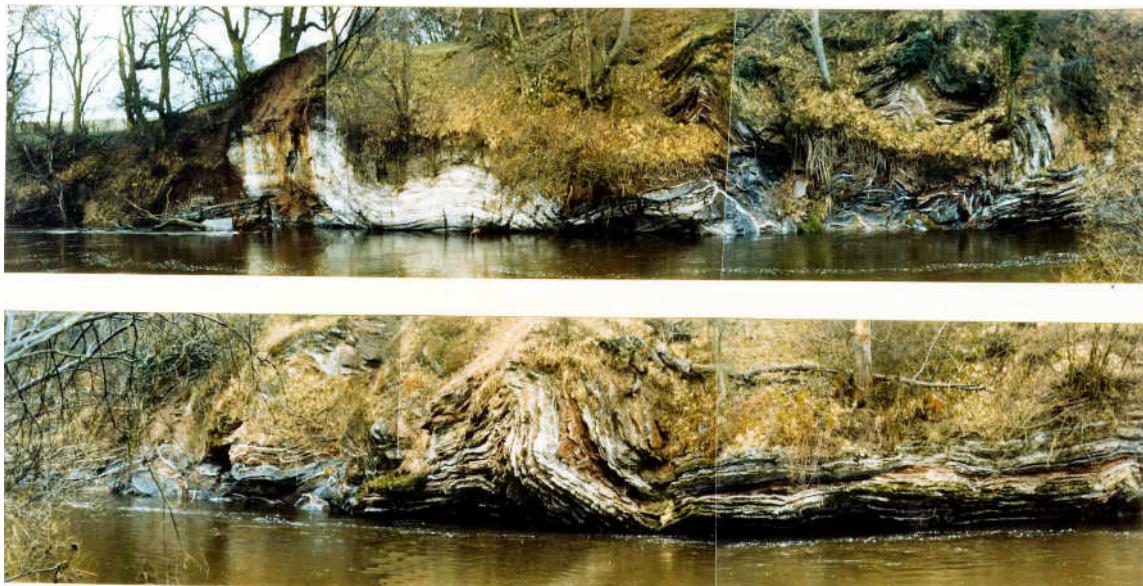
Figure 5. The gypsum cliff next to the River Ure at Ripon Parks, Norton Conyers. The cliff has changed considerably since this photograph was taken in April 1980. Firstly the massive gypsum became undercut by about 6m in 10 years. The cliff then collapsed and continued to be dissolved. Much of the southern end (top photo, left) has dissolved and collapsed revealing a collapsed area of fill materials from the overlying sequence. The recumbent fold (bottom photo, middle) has also become undercut and collapsed a couple of years ago. The dissolution of the cliff and the lithological details are given in James et al., 1981.

Locality 1. Gypsum cliff at the side of the River Ure, Norton Conyers Park [SE3075, 7528]. Here the Edlington Formation gypsum is exposed next to the River Ure. The gypsum in this formation is locally up to 35m thick and here the upper 10m or so of the gypsum and the overlying gypsiferous mudstone are exposed. The southern end of the section has suffered dissolution in the past and there is an area of founded Brotherton Formation just downstream. This suggests considerable dissolutional activity prior to the last (Devensian) ice age as glacial till deposits cut across the top of the subsidence features. The recent history of the cliff's dissolution has seen it cut back by about 15metres in the last 25 years.

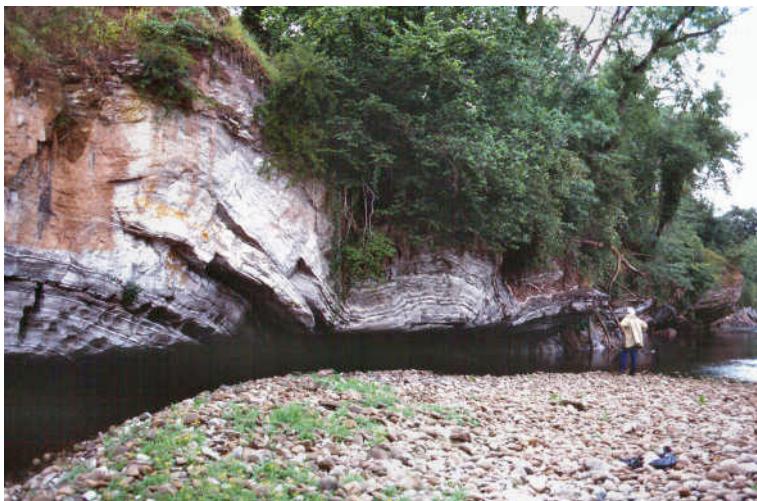
Figure 6. The gypsum cliff in 1990 just before it collapsed showing the complete flow of the River Ure going under the face.

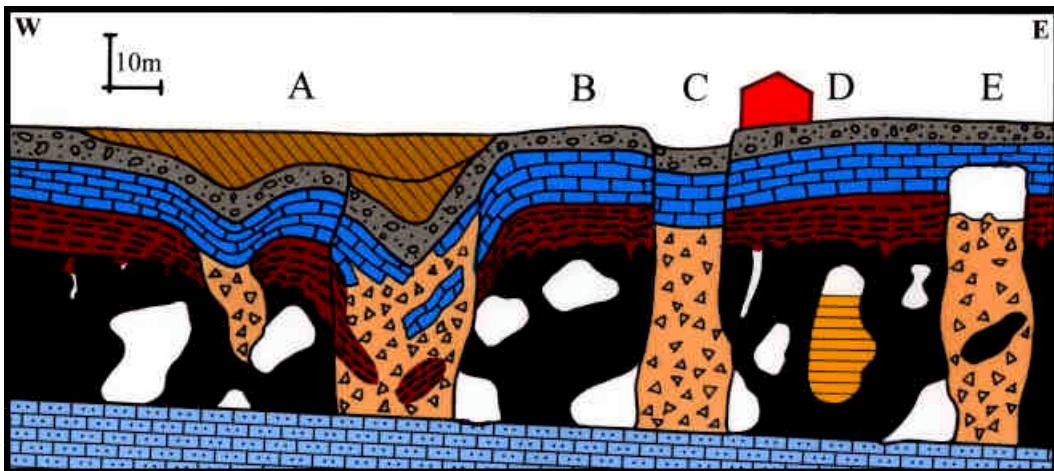
Figure 7. Cross-section through the middle part of the gypsum subsidence belt. See Figure 3 for legend.

Locality 4. Ripon Clock Tower [SE 3133 7182], the site of a small subsidence hollow that occurred in 1987, but is now filled in. This hole is adjacent to a large area of amalgamated subsidence hollows filled with peat and soft clay. The geological situation here equates with A on Figure 7.

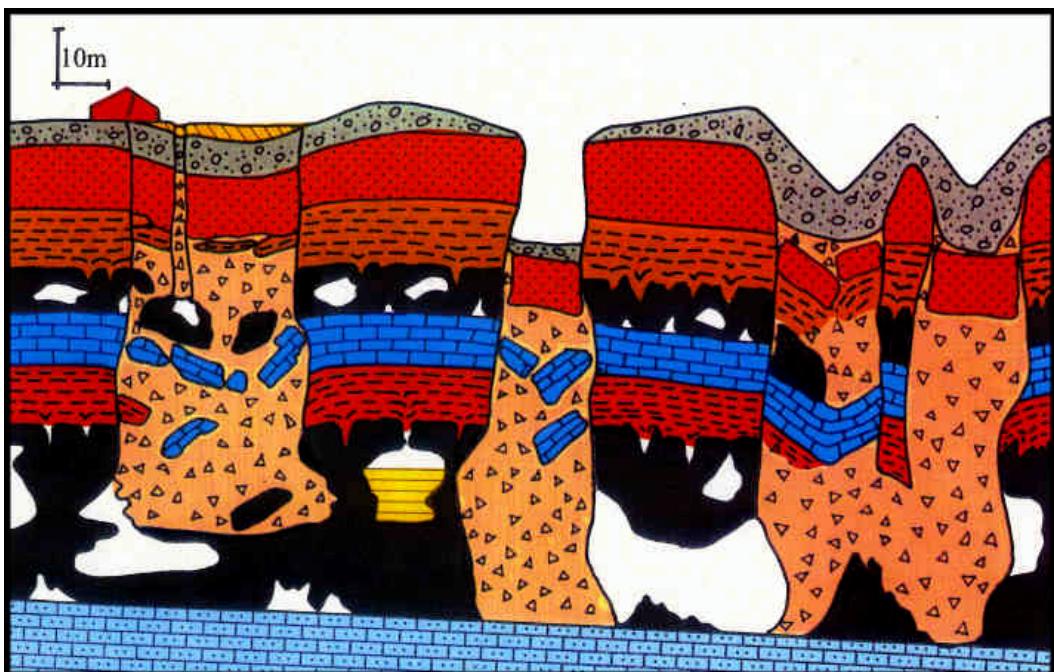
Figure 8. Cross-section through the eastern part of the gypsum subsidence belt, see Figure 3 for legend. The large subsidence in the middle of the section equates with the geological situation seen at locality 3.

Locality 3. Subsidence hollow behind the old Ripon Railway Station site [SE 3186 7260] (Figure 8). This subsidence hollow formed in July 1834. It is cylindrical in form (14m in diameter and 15m deep) with slightly overhanging sides. "Solid" red sandstone of the Sherwood Sandstone Group is exposed in the sides of the hollow and there is a thin covering of glacial till.

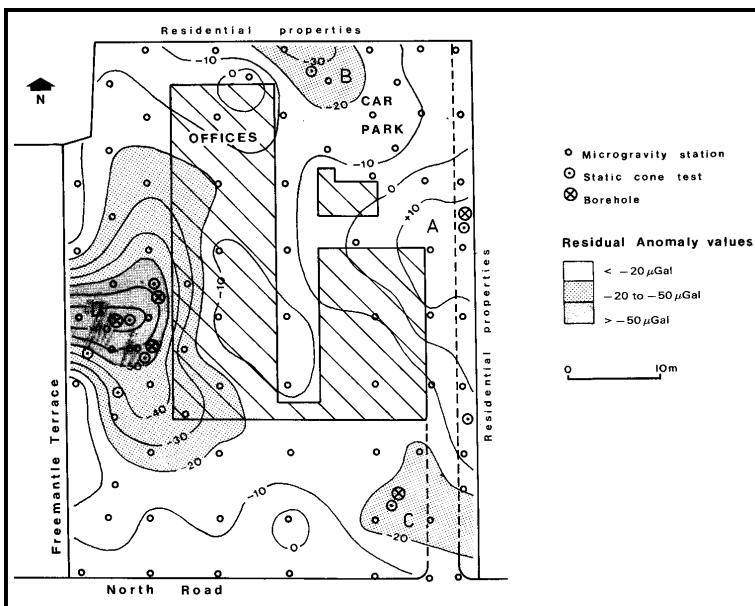
Figure 9. Plan of the former Ripon Tax Office site showing the microgravity results, cone penetrometer and borehole locations (from Patterson *et al.* 1995).

Locality 7. Former Tax Office. [SE 3155 7200]. No subsidence features are visible here, but a deep subsidence pipe was proved by microgravity geophysics and drilling on the west side of the site (Patterson *et al* ., 1995) (Figure below)

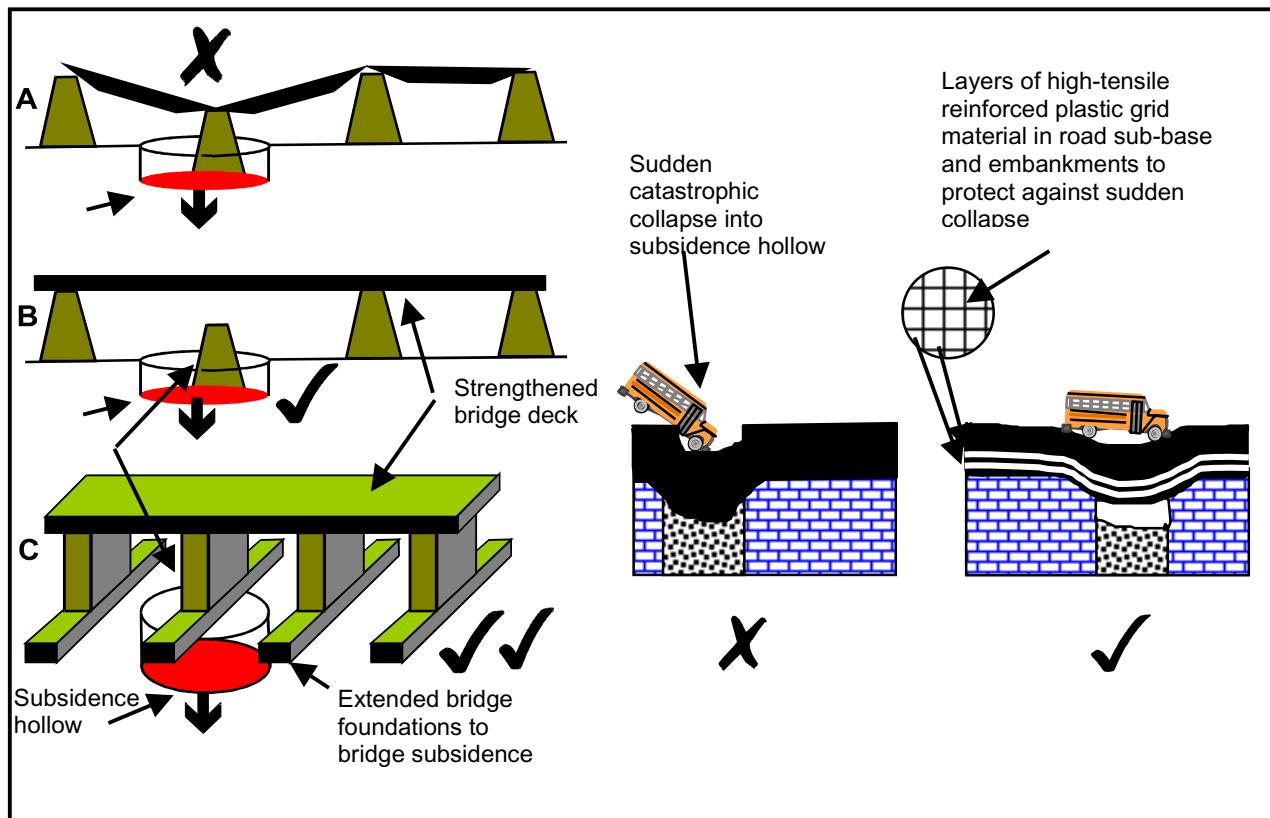
Figure 10. (Left) Sacrificial supports and extended foundations in bridge construction to protect against sudden subsidence failure. **(Right)** The use of geogrid material in road construction to protect against sudden collapse.

Linear structures such as roads and bridges are very prone to subsidence damage. At Ripon, the new Ure Bridge is built with redundant strength and the capability for the structure to lose any one of its pillar supports without collapse (Figure 10, plus Cooper & Saunders, 2002). On the same stretch of road, the embankments are protected by two layers of strong geogrid material sandwiched in the embankment fill (Cooper & Saunders, 2002; Jones & Cooper, 2005). This sandwich of material is designed to span cavities up to about 15m across and sag rather than fail so that an indication of any problem becomes visible at the surface.

Locality 9. New road bridge over the River Ure [SE 3186 7195]. This bridge has been strengthened and has been designed to remain stable (but not usable) even if one of the piers fails. Electronic load monitoring is incorporated in the piers. The approach roads are strengthened with several layers of geogrid material; on less severe ground around Derby, on Triassic gypsum, the road is protected by reinforced concrete over stabilised cavity fill (Cooper & Saunders, 2002; Jones & Cooper 2005).

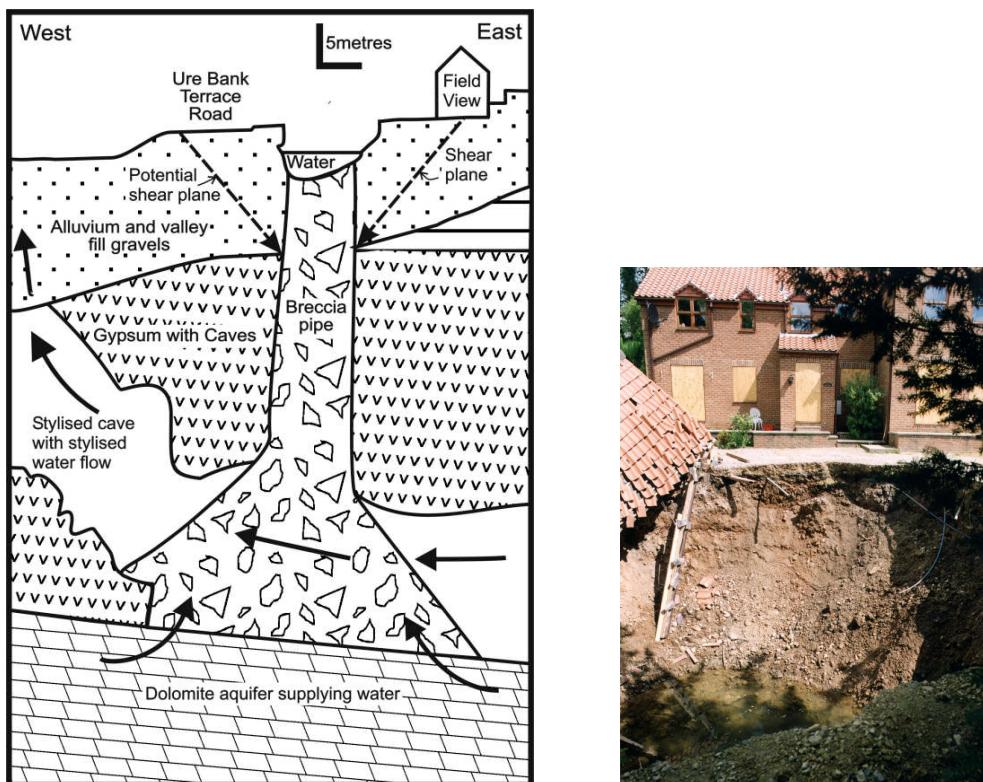
Figure 11. Schematic cross section and photograph of the Ure Bank Terrace collapse in early May 1997.

Locality 15. Subsidence hollow, damaged garages and threatened houses on Ure Bank Terrace [SE 3153 7242]. This hollow started its present phase of subsidence on 15th February 1995. Initially it was about 6m across, now it is 10m across and 5.5m deep. The latest and largest collapse was on 23rd-24th April 1997; It has been filled and collapsed 6 times since 1995. The hole has a long history of subsidence and was noted to have previously moved in 1968 and 1970 (Cooper, 1986). There are still legal problems over the liability for the hole and the responsibility for keeping it filled and moderately stable. A report commissioned by the Council (Cooper, unpublished) suggested filling the hole with granular material that would funnel into any cavities. This would help to support the sides (and the road) and also make any movement obvious. Taking advice from consulting engineers, the hole was filled in late 1999 with 37.5mm, type B, filter drain material which is readily available (Cooper, 2005). The material has continued to funnel into the hole and there is now a conical depression; the hole is in need of refilling, but no one wishes to take the responsibility.
